Olympic Challenge

Scanning plays a critical role in the evolving design and construction of the Olympic Stadium in London.

Scanning London's

Olympic Stadium

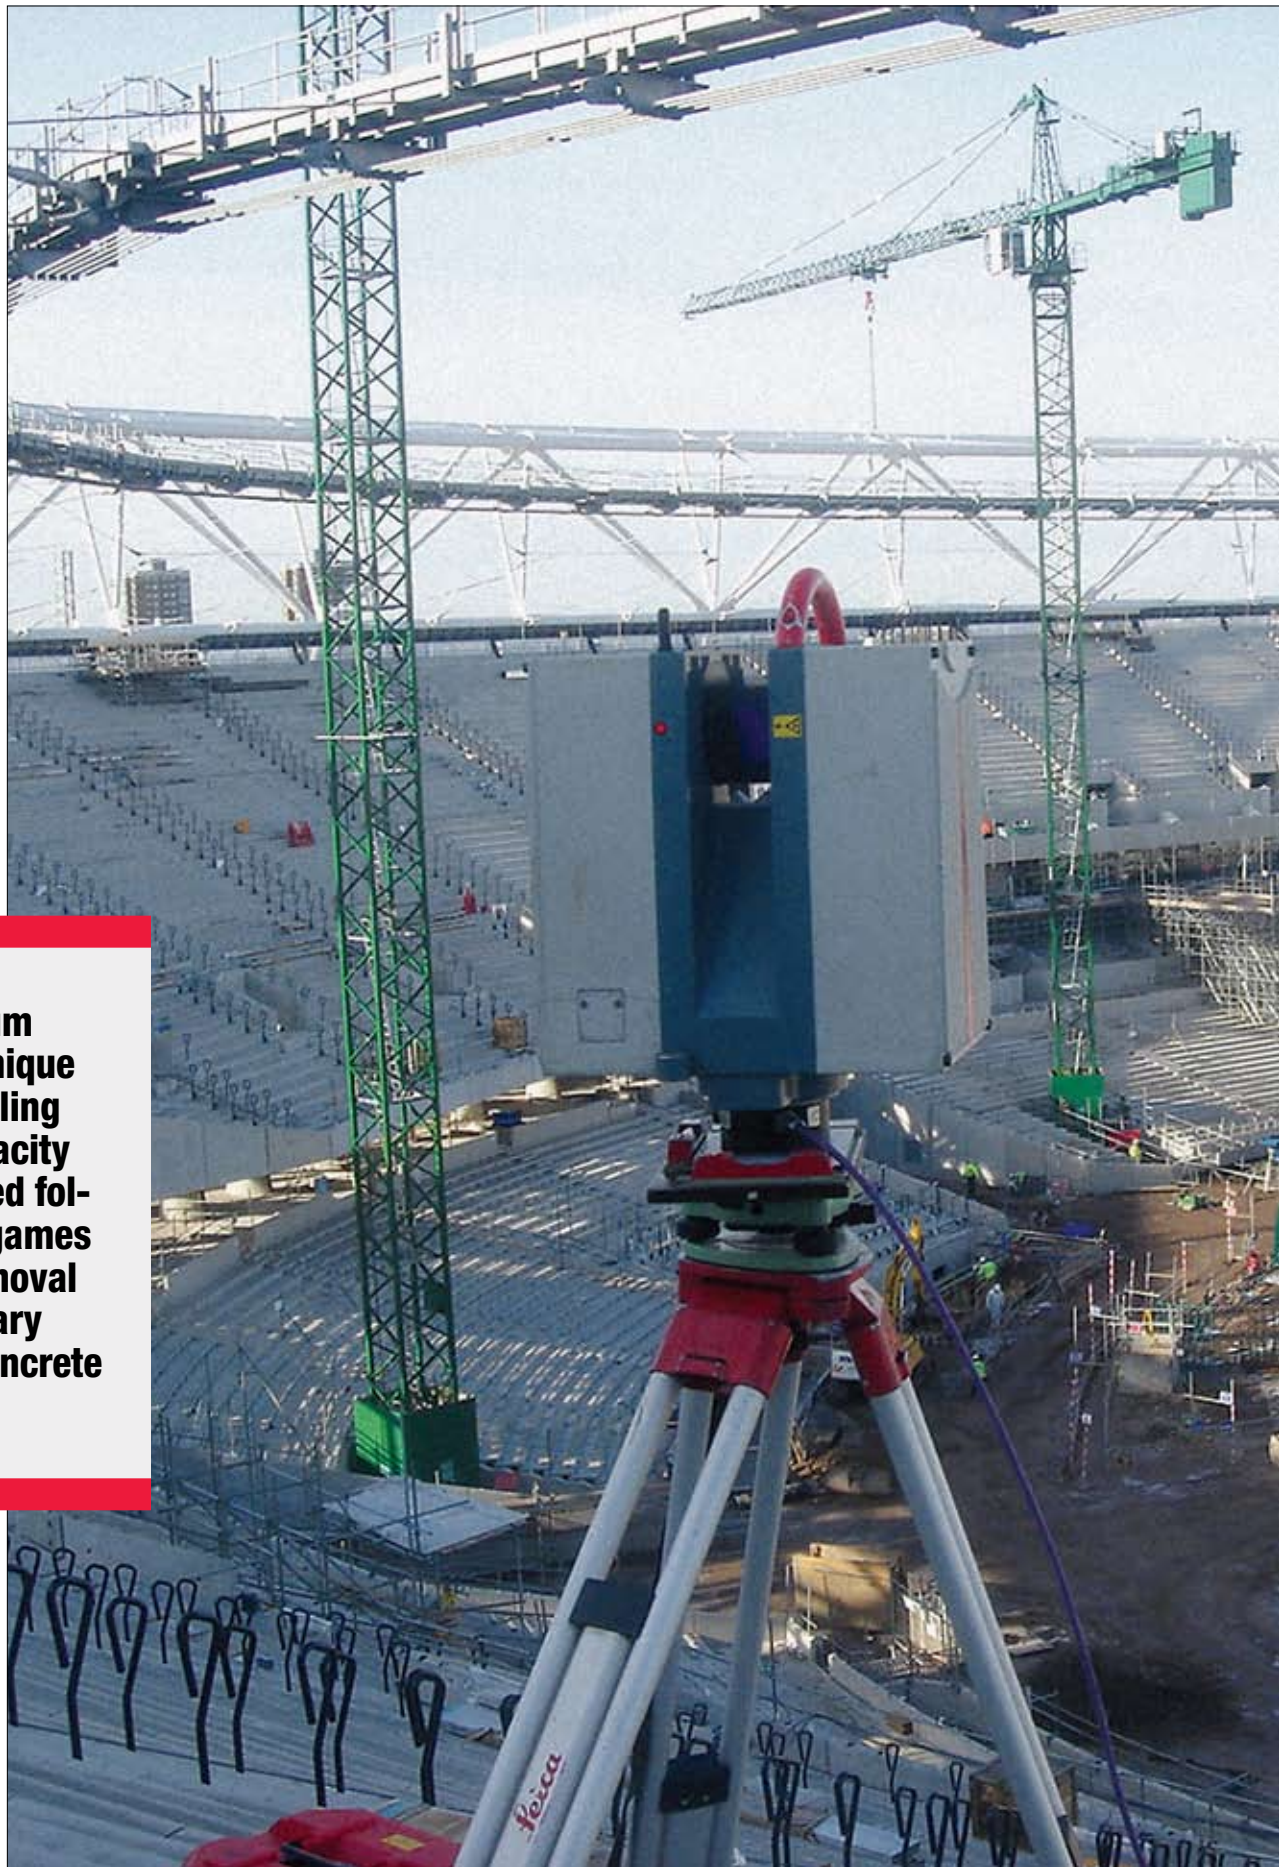
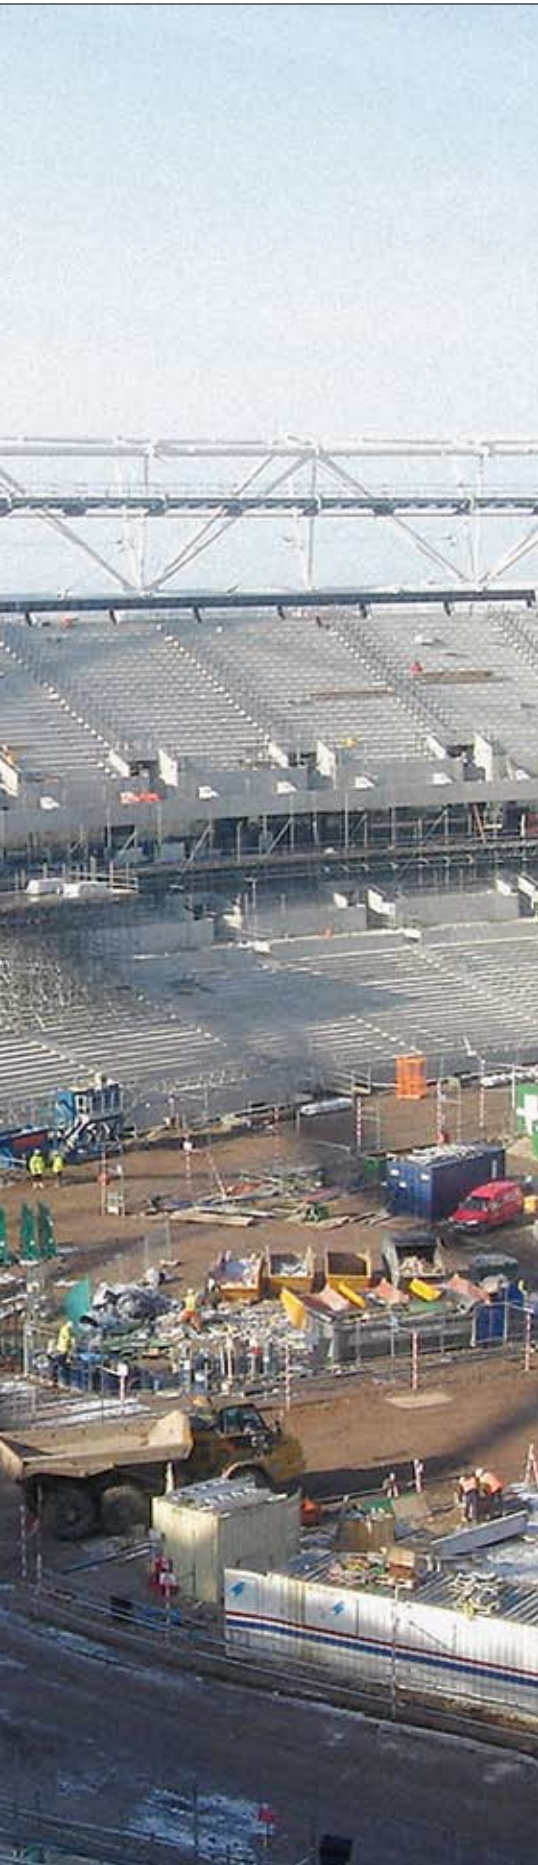
The upper tier terrace and roof-supporting structure are constructed from pre-fabricated compression truss- and roof-column connections with cables supporting a roof structure of PVC fabric.

Team Stadium created a unique design enabling seating capacity to be reduced following the games with the removal of a temporary steel and concrete upper tier.

The upper section supporting the stadium's partial "roof" is constructed from pre-fabricated compression truss and roof-column connections with cables supporting a roof structure of PVC fabric. Triangular lighting support towers stand on top of the roof structure.

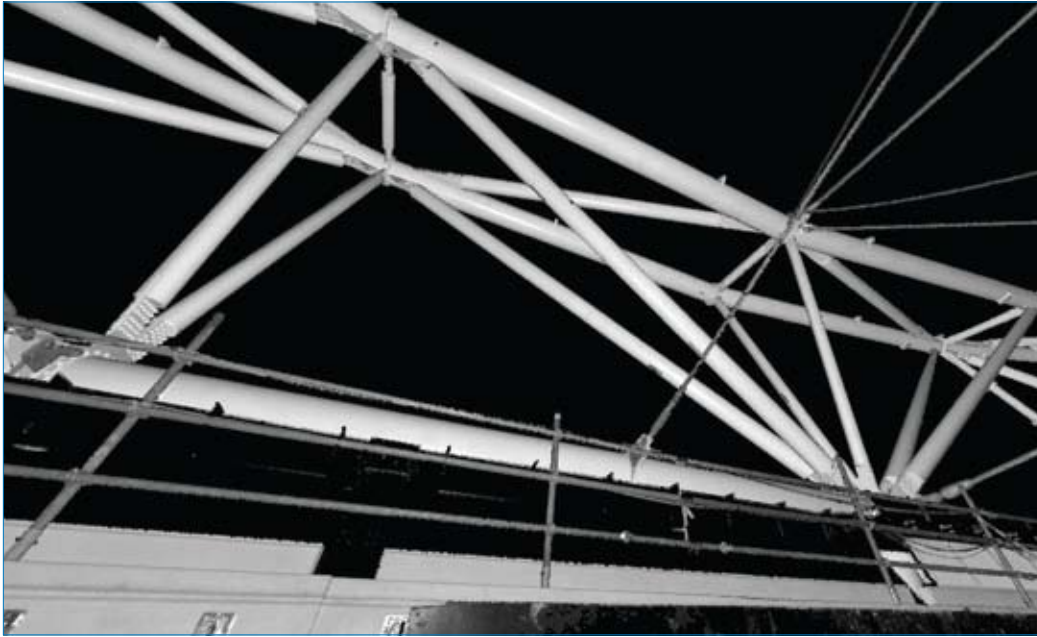
This high-resolution scan of the roof-supporting structure was taken using a high-speed phase-based 3D laser scanner. The point cloud is displayed in grey-scale intensity mapping, with locating holes and individual rivets visible.

The locating hole positions were clearly visible in the high point density scans. Once again, an area of the point cloud was worked on in a new model space, and the holes were located with the aid of parts templates, which the team had constructed to aid the fitting process.

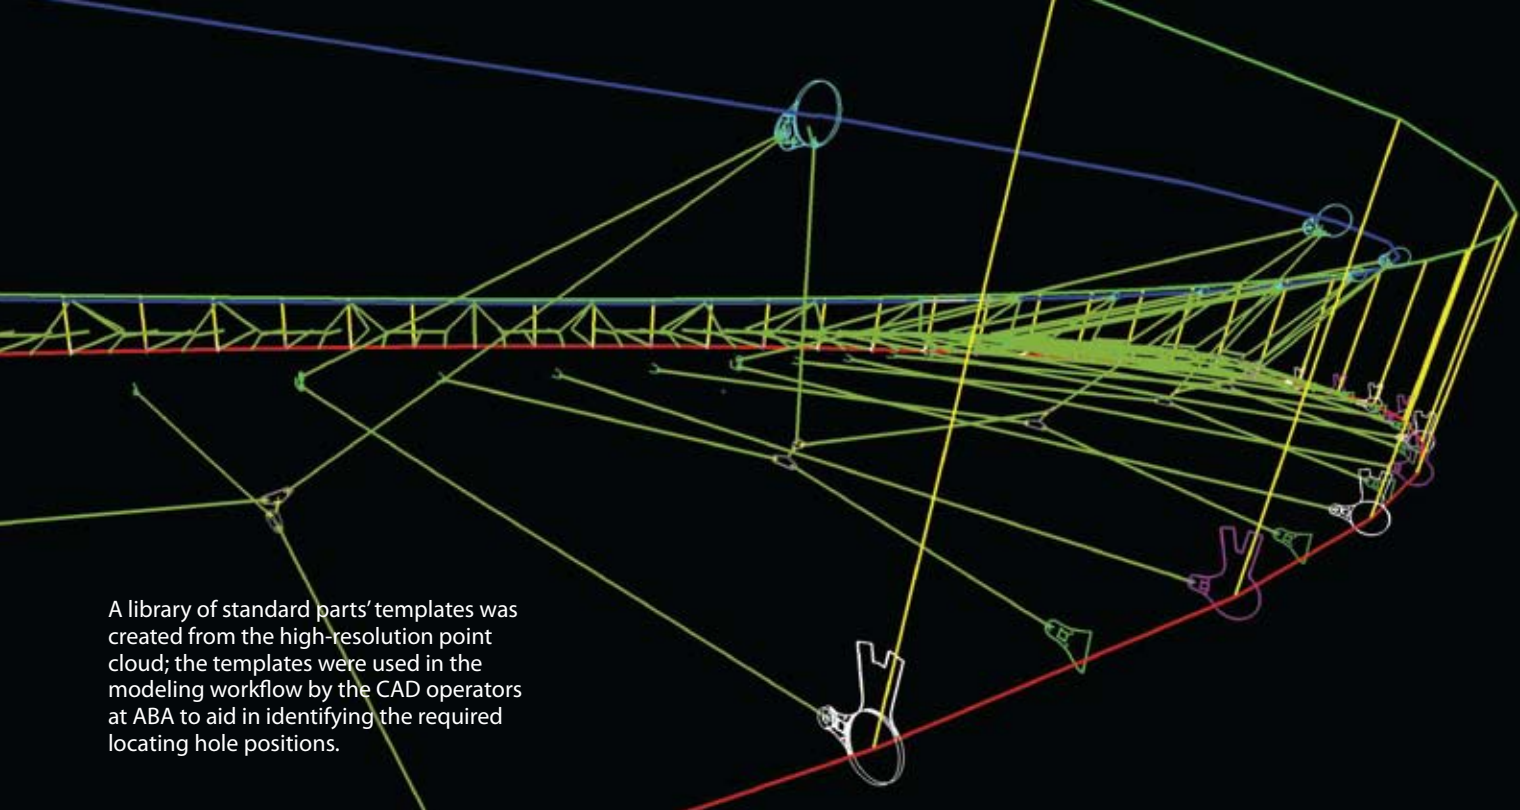
A library of standard parts' templates was created from the high-resolution point cloud; the templates were used in the modeling workflow by the CAD operators at ABA to aid in identifying the required locating hole positions.
